DAMAGE TO EIGHT-STORY RC BUILDING RETROFITTED TO HAVE BASE SHEAR COEFFICIENT OF 0.65

ABSTRACT: An eight-story reinforced concrete building retrofitted according to the 1990 Japanese Standard was severely damaged during the 2011 Tohoku earthquake. The building was constructed in 1966 at Tohoku University. In 1996 the building was retrofitted using structural walls and carbon fiber. The base shear coefficients of the building in the longitudinal and transverse directions after the retrofit were estimated to be 0.67 and 0.65, respectively. This paper discusses the reasons for the severe damage that took place despite the retrofit.

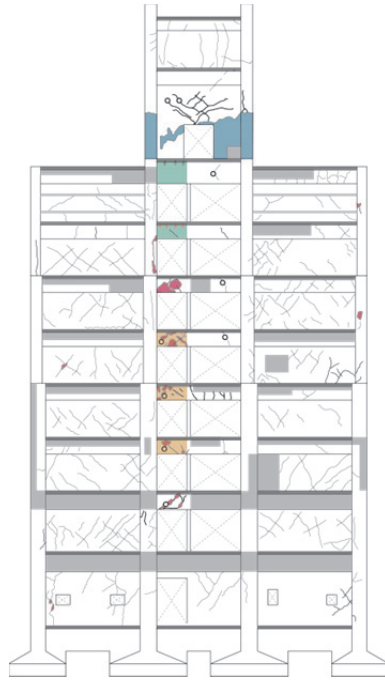
Fig. 5 Frame 11 cracks schedule

The heaviest damages in the building are located mainly in beams and in the penthouse. Damages in the first story were minor. Figures 3-6 shows the observed cracks in selected frames. The grey shade shows the parts that were not visible, the green one represents carbon fiber reinforcement, the brown one is tape-shaped reinforcement, the red one is detached concrete and the blue one is completely destroyed concrete. Also the thickness of cracks represents cracks between 0.2-1.00 mm, 1.10-2.00 mm and above 2.00 mm. The blue cracks were not measured. The most damaged stories in decreasing order were third, fourth and fifth stories. Regarding to the frames in X direction, damages were more prominent in frames I and J with walls (Fig. 3) than open frames H and K. In Y direction, damages in the penthouse were large as shown in Figs. 4 and 5. Damages in the beams with openings were also prominent as shown in Figs. 5 and 6.

Due to the damages seen in frame 11 (Fig. 5) the short beams between frames I-J failed in shear. Therefore, the failure mode as shown in Fig. 18 is assumed to estimate the lateral capacity of this frame. In this model the walls of frames H-I and J-K are strong enough while the coupling beams fail. For the analysis the first story is considered as rigid, because it does not have significant damages. These walls rotate as shown in Fig. 18 and vertical reinforcement bars are assumed to be yielded at the bottom of the second story, where a_t is the cross section area of the longitudinal reinforcement on boundary column and σ_y is the yield strength of the steel. The values N_1 and N_2 are the long term loading axial forces through the boundary columns of the walls. The double circle in this figure represents the plastic hinge of the joint and its plastic moment is computed as sum of the plastic moment of the column and that of the beam.

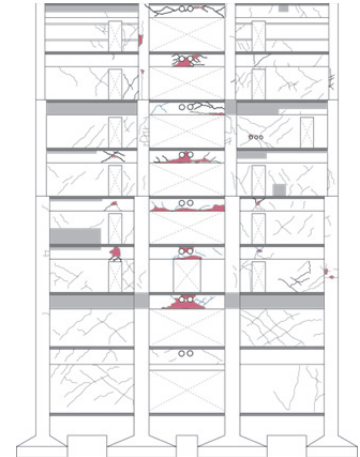
Fig. 6 Frame 14 cracks schedule

Severe damages were also detected in the coupling beams of the frame number 14. They have two 300 \varnothing openings at their midspans and were highly damaged around this area (Photo 12). These openings have been detected also in all the coupling beams of the frame 11 and in some of the frame 9.

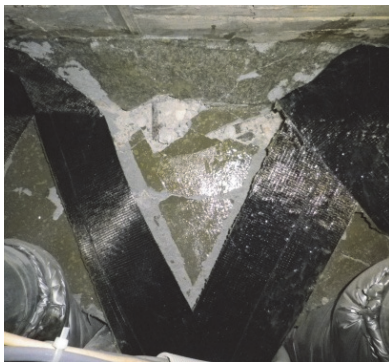
Carbon fiber reinforcement has been used in short and normal beams. The short beams took a lot of damage and failed in shear, while the other beams, even the not reinforced ones, had less damage. Different failures in the carbon fiber of the short beams can be identified such as unstuck tapes (Photo 5), peeled-off tapes (Photo 6), broken fibers (Photo 7), torn fibers (Photo 8) and failure of anchorages (Photos 9 and 10).

Photo 5 Unstuck tapes
Floor 5 Frame 12 Beam I-J

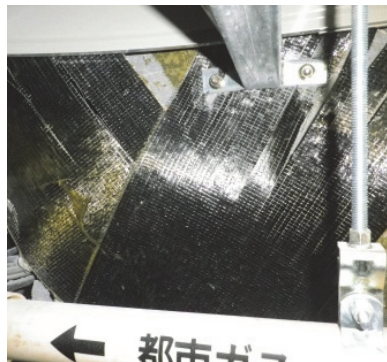
Photo 6 Peeled-off tapes
Floor 5 Frame 11 Beam I-J

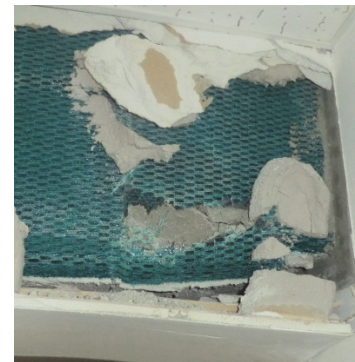
Photo 7 Broken fibers
Floor 7 Frame 11 Beam I-J

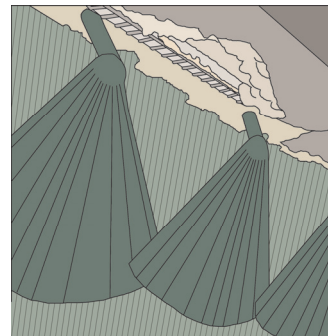
The most severe damage in this group is the failure of the anchorage of two of the carbon fiber reinforcements that were visible. In the last photo the damage was so great that a rebar was visible. For clarifying the photo of the failure a zoom and a drawing are provided in Photo 11 and Fig. 7:

Fig. 7 Drawing of the failure in Photo 10

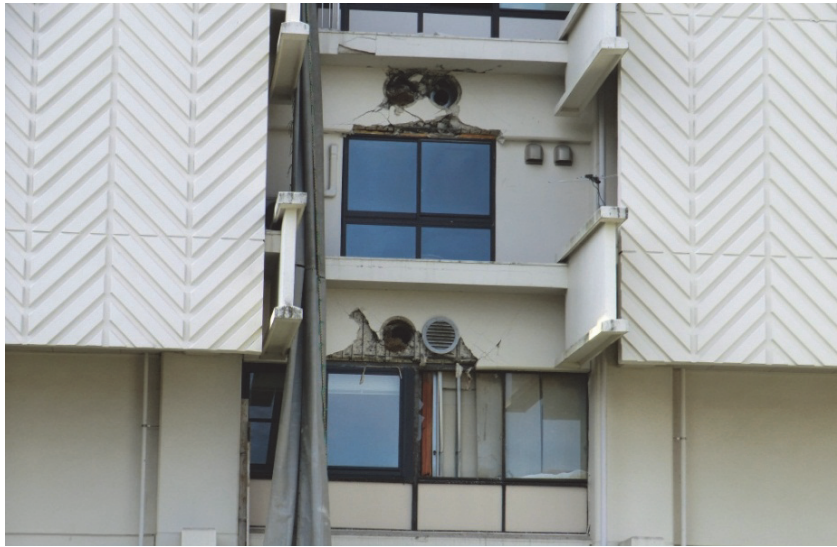
Photo 12 Coupling beams damaged around openings
