Seismic capacity of retrofitted SRC building damaged due to 2011 Great East Japan Earthquake

M. Maeda¹, K. Suzuki², H. Al-Washali³, S. Pujol⁴ and T. Ichinose⁵

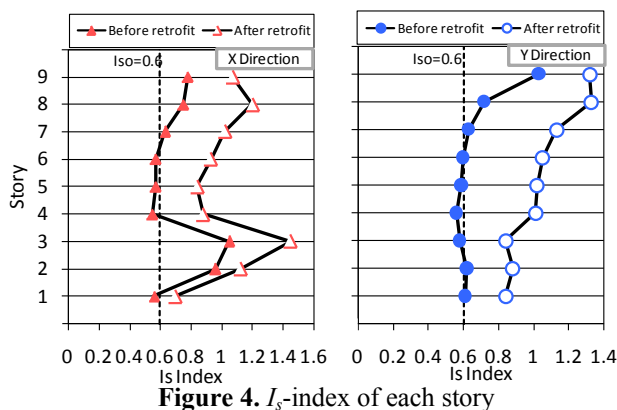
Figure 4. I_s -index of each story

S_D and T are reduction factors to modify E_0 considering of structural irregularity and deterioration after construction, respectively. The Seismic Evaluation Standard recommends as the demand criterion that I_s -Index higher than 0.6 should be provided to prevent major structural damage or collapse. Figure 4 shows the I_s -index of all stories for both before and after retrofit. This building was retrofitted because I_s -index was less than 0.6 for most stories. It should be noted that the F index (ductility index) used here was 3.5 assuming the building has very ductile flexural walls.

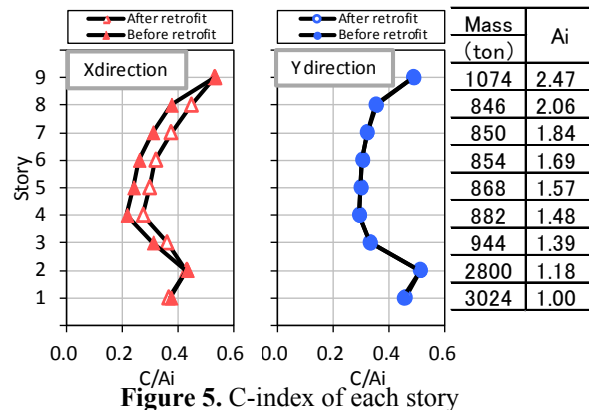
Figure 5. C-index of each story

Figure 5 shows the C -index $/Ai$. 1st and 2nd stories have higher lateral strength ($C/Ai=0.4\sim0.5$) than upper stories in both directions. In the Y direction, 3rd-8th stories have approximately the same C/Ai value (=about 0.3). $C/Ai = 0.3$ is the minimum requirement for RC buildings in the current seismic code in Japan

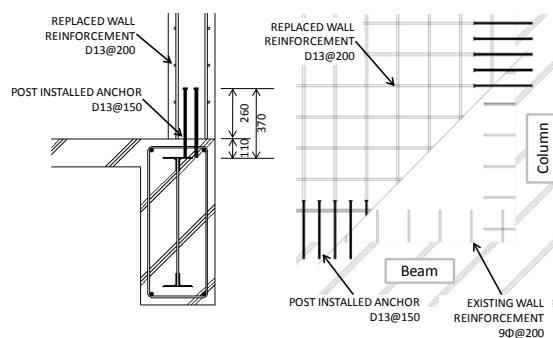
Figure 7. Detail of wall replaced

The reinforcing details of the shear panels replaced in walls X3 and X8 shown in Figure 7. It is important to emphasize that development length of post installed anchors were 110mm according to the regulation for seismic retrofit design. The length of anchor met the guidelines for seismic Retrofit of Existing Reinforced Concrete Building (JBDPA 2001). However, the tensile strength of anchor is conditioned on cone shaped fracture, as can be seen in Figure 13.

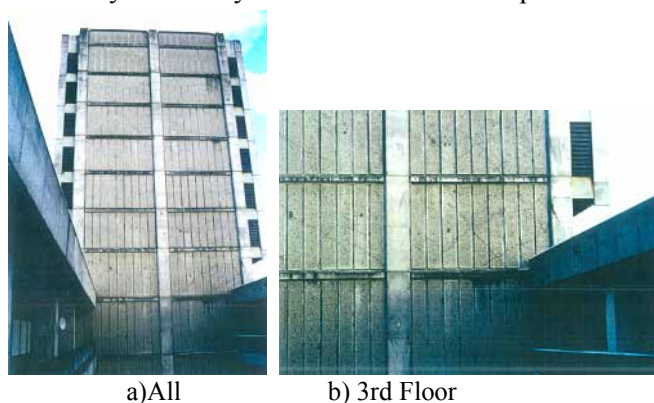
Figure 8. Damaged wall in 1978 Miyagi Oki

Detailed damage survey was conducted after the 1978 Miyagi Oki earthquake by professors Shiga and Shibata, Tohoku University (Shiga et al. 1981). According to their report, small shear cracks and flexural cracks were observed in exterior shear walls (see Figure 8), adjacent beams and a few columns on the third and fourth floor. Typical wall and short beams crack patterns are shown in Figure 9 and 10. The maximum width of shear cracks in shear walls and that of flexural cracks in columns and beams are reported about as 1.0mm. The width of shear cracks in the adjacent beams with openings was reported about as 1.5mm. Therefore, the structural damage of the building by the 1978 earthquake, was considered to be fairly minor. As can be seen in Figure 10, exterior shear wall successfully sustained lateral force and contributed as shear resisting elements, because shear cracks were relatively uniformly distributed in the wall panels.

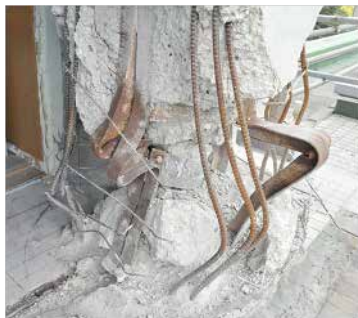
Figure 11. X8-Y2 column after remove the crush concrete

The authors carried out detailed damage surveys of the building after the 2011 earthquake. The most severe damage occurred in the 3rd story. Four corner boundary columns in exterior walls X3 and X8 (which were intervened in 2001) fractured as shown in Figure 12a). A close-up of the disintegrated near their bases, and the steel angles and reinforcing bars embedded in them either buckled on the base of column X8-Y2 is shown in Figure 11.

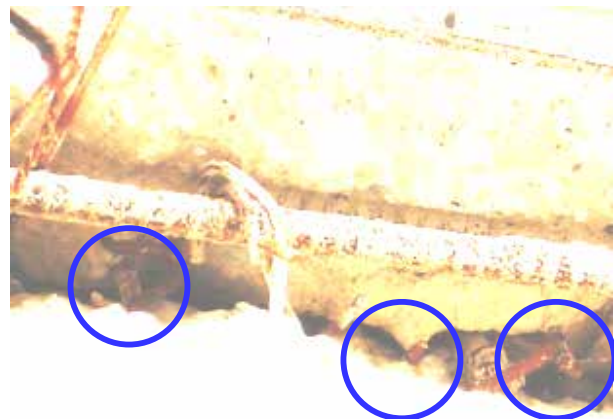
Figure 13. Zoom viewing of wall anchor

Figure 12 shows cracks observed on the exterior walls in the transverse direction. A horizontal separation was formed at the base of the third story, between the post-installed structural wall panels (shown in Figure 12b)) and the beam supporting them. The post-installed anchors that were supposed to prevent this separation appeared to have been pulled out of the beam as shown in the close-up in Figure 12c) and Figure 13.

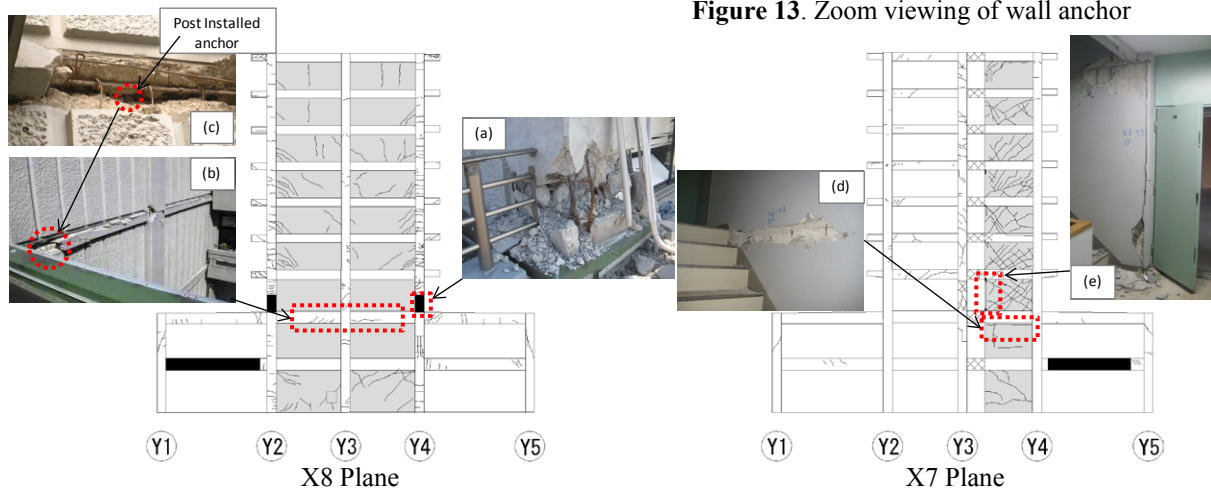
Figure 12. Crack patterns after 2011 Great East Japan earthquake

Along axes X4 to X7, shear cracks with widths of up to 1.7mm were observed on “wing walls” and “stems” forming the staircases in all stories. Spalling of concrete and a large horizontal crack were

observed at the 3rd floor level (Figure 12d, e)). The damage and cracks of the wing walls indicate the interior C-shape walls remained integral and were effective in resisting lateral loads.

Though the bases of exterior boundary columns disintegrated, the webs of the exterior walls had little (or imperceptible) cracking in the 2nd to 3rd stories, and thin cracks (0.1~0.2mm) elsewhere. Comparing the damage caused to these walls by the Earthquakes of 2011 (Figure 12) and 1978 (Figure 9) suggests that there was a radical change in the mechanism through which these walls resisted lateral loads. It seems that in 1978 the exterior walls acted as units (composed of webs and columns connected to integrally), while in 2011 the webs did not seem to contribute much to lateral resistance. It is assumed that the buckling of the steel triggered the disintegration of the concrete at column bases, because the exterior columns along axis Y3 exhibited bar buckling and spalling of concrete despite the fact they resisted with no compression at peak displacements.

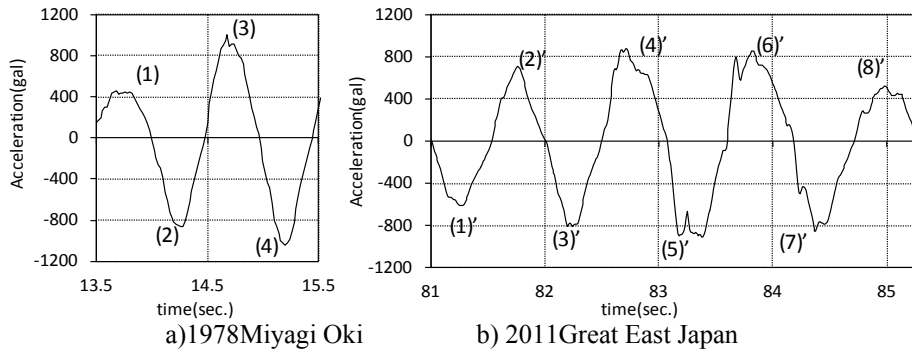
Figure 16. Zoom viewing of acceleration time history

Figure 16 shows the partial time history of 9th floor acceleration obtained in 1978 and 2011 around the maximum response. The waveform is just smooth because this building dominates the 1st mode in 1978 Miyagi Oki earthquake. Also, the response of 9th floor is stable after the maximum displacement at (4).

Similarly, the waveform before maximum response((1),(2)') in 2011Great East Japan earthquake is quite smooth. However, after the maximum response((4)~(6)'), the waveform shows irregularity such as sudden drop and unstable.

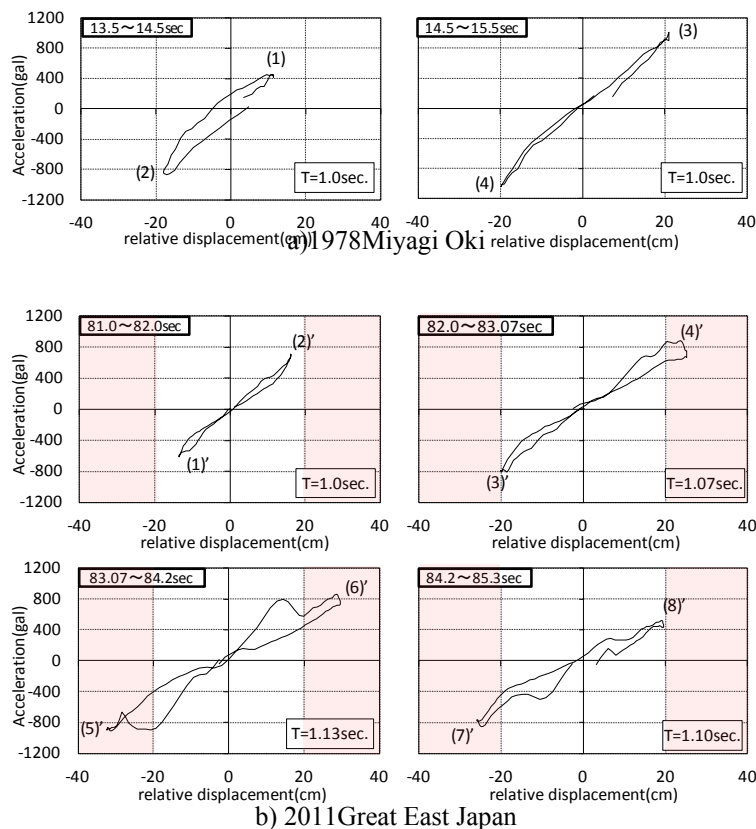
Figure 17. Dynamic hysteresis loop

In case of 1978 Miyagi Oki earthquake (Figure 17a)), the hysteresis loop from 13.5sec. to 14.5 sec. is fat loop having the large hysteresis area. However, the hysteresis loop form 14.5sec. to 15.5sec., when the maximum displacement 20.0cm was observed, is similar to linear elastic behavior without remarkable energy dissipation.

On the other hand, Figure 17b) shows the dynamic hysteresis loop of 2011 Great East Japan earthquake. The hysteresis loop before the maximum displacement of 1978 Miyagi Oki earthquake draw the inverse "S" shaped loop, which is similar to 1978 Miyagi Oki earthquake. However, the acceleration reached the ceiling about 800gal at peak (3)' and sudden dropped at peak (4)' to (6)'.

After that, the hysteresis loop drew unstable and origin oriented shape. Also at the same time, the relative displacement exceeded the maximum displacement, 20.0cm, observed in 1978 Miyagi Oki earthquake. From these facts, it is assumed that boundary columns fractured at peak (4)' to (6)' where the displacement exceeds the experienced maximum response displacement.

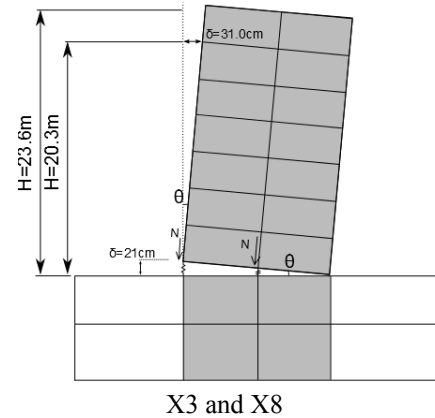
Figure 18. collapse mechanism

The mechanisms of failure for the main structural elements (the walls) were dominated by flexure. Eventually, the ground motion caused the steel angles and reinforcing bars in boundary columns in axes X3 and X8 to buckle and fracture, and the anchor rods meant to fasten the webs to the beams were pulled out. At that point, the response of the exterior walls approached the response of a rocking block. This rocking behavior was inferred by Motosaka (2012) from wave analysis. If the lateral displacement on the 9th floor reached 31 cm, the uplift must have approached 21 cm. Walls and frames along column lines X4 to X7 are not suspected to have uplifted because their vertical reinforcement was continuous and well anchored.

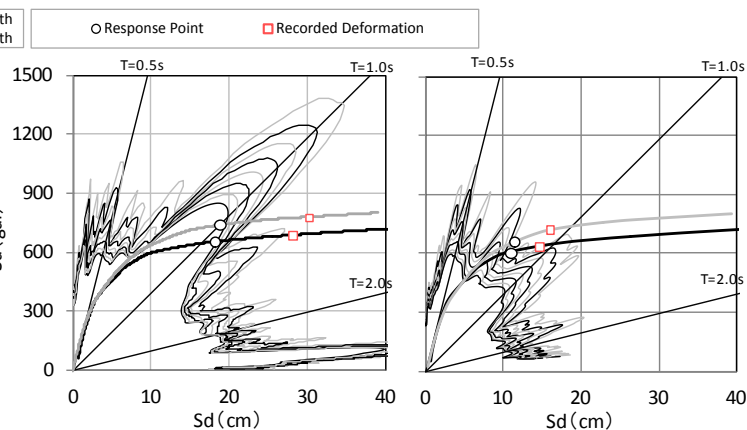
Figure 21. Result of estimated building response (2011 Great East Japan)

The estimation results of response displacement and equivalent period agrees well with observed value on the case of 1978 Miyagi Oki earthquake(see Figure 20). However, there is big difference on the case of 2011 Great East Japan earthquake. As described at the Chapter 3, failure pattern of the building in 2011 was completely different from those in 1978, namely post installed anchors in wall panels pulled out and boundary columns were crushed.

As described at the Capter4, fracture of column is consider to occur around 82.0sec. Therefore structural characteristics are considered to change, and the acceleration records could be divided into 2 parts at the time 82.0sec. Then, the response analysis from 0sec. to 82.0sec. at 2011Great East Japan earthquake was carried out. Thereby, estimated response displacement and equivalent period are in good agreement with observed one. These almost have similar accuracy with the case of 1978 Miyagi Oki earthquake. Accordingly, the rocking movement from 3rd to 9th story by the fracture of boundary columns causes the difference between estimated and observed response at 2011 Great East Japan earthquake.
