DAMAGE TO EIGHT-STORY RC BUILDING RETROFITTED TO HAVE BASE SHEAR COEFFICIENT OF 0.65

ABSTRACT: An eight-story reinforced concrete building retrofitted according to the 1990 Japanese Standard was severely damaged during the 2011 Tohoku earthquake. The building was constructed in 1966 at Tohoku University. In 1996 the building was retrofitted using structural walls and carbon fiber. The base shear coefficients of the building in the longitudinal and transverse directions after the retrofit were estimated to be 0.67 and 0.65, respectively. This paper discusses the reasons for the severe damage that took place despite the retrofit.

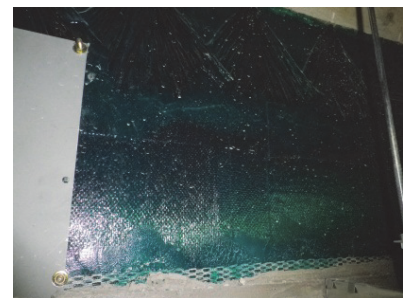
Photo 4 Stuck carbon fiber reinforcement with anchors

The building was retrofitted in 1996 according to the 1990 Japanese Standard (Building Research Institute 2001). The main changes during the retrofit were addition of new walls, change concrete walls for new and thicker ones and reinforcing some of the beams of the building with carbon fiber. According to the documents for the retrofit design, the base shear coefficients of the building in the longitudinal and transverse directions after the retrofit were estimated to be 0.67 and 0.65 respectively. While the wall changes were concentrated in lower stories, from first to fifth stories, the carbon fiber reinforcement has been located mostly in the upper ones. About the location of the carbon fiber reinforcement, since there was no documentation of where was applied, a deep field investigation was needed. From the total of 159 short beams in the building only 109 were visible. The fiber was used in 24 of them, specifically in those in the third to eight stories. However, the fiber was not only used in short beams, but this reinforcement was also found in 7 additional beams. There were three kinds of fiber reinforcement: the first one is tape-shaped (Photo 2), the second one was a continuous fiber wrapping all beams (Photo 3) and the third one is similar to the previous one but with anchorages inside the concrete (Photos 4). Regarding to the penthouse no retrofit was done.

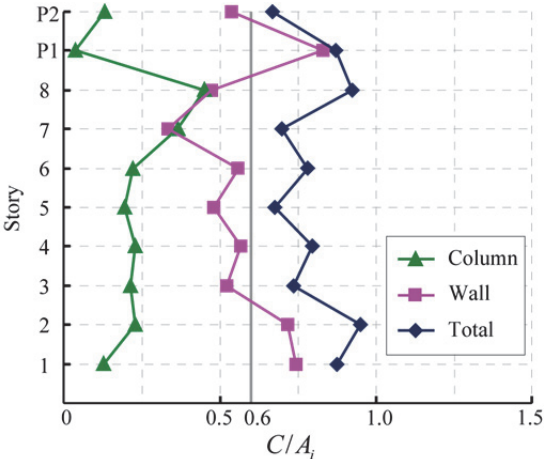
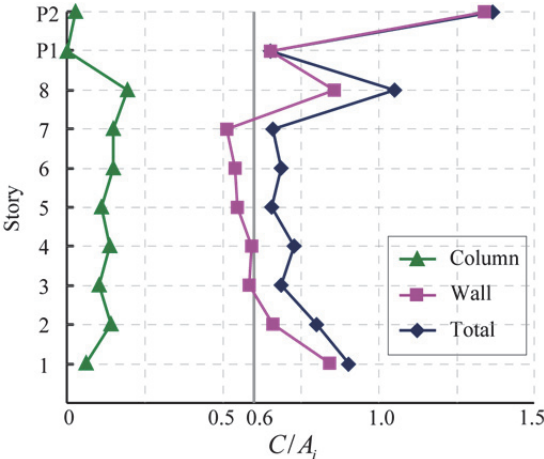
According to this graphs in X direction the second and eighth stories are the strongest ones and the second story of the penthouse is the weakest one. Referring to the Y direction the second story of the penthouse is by far the strongest, and the fifth and first story of the penthouse are the weakest.

Regarding to the analysis of the penthouse, the results of the analysis in Figures 16 and 17 show how the damages at the first level of the penthouse could be predicted when comparing the coefficients with the ones of the other stories. However, the C/A_i coefficient of the penthouse is still 0.653, which should be enough.
