Seismic capacity of retrofitted SRC building damaged due to 2011 Great East Japan Earthquake

M. Maeda¹, K. Suzuki², H. Al-Washali³, S. Pujol⁴ and T. Ichinose⁵

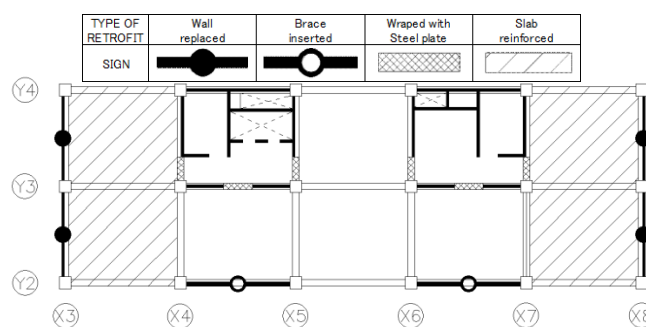
Figure 6. Part of retrofit plan

According to the seismic evaluation results, seismic capacity I_s -index was insufficient to requirement of $I_s=0.6$ and was classified as a retrofit candidate. In 2001, the building was seismically retrofitted by installing framed steel braces in the longitudinal direction, replacement of RC shear walls in transverse direction (frame X3 and X8) from the 3rd to 9th story, and jacketing of adjacent short beams with steel plates to avoid shear failure, as shown in Figure 6. The main scheme of the seismic retrofit was to increase I_s -index to meet the criteria of $I_s \geq 0.6$. The retrofit plan was to increase the ductility of the transverse direction by replacing the exterior shear walls with new exterior shear wall.

As for the longitudinal direction, steel braces were installed to increase lateral strength and also to reduce the torsion vibration induced by the irregularity of the structure in this direction.

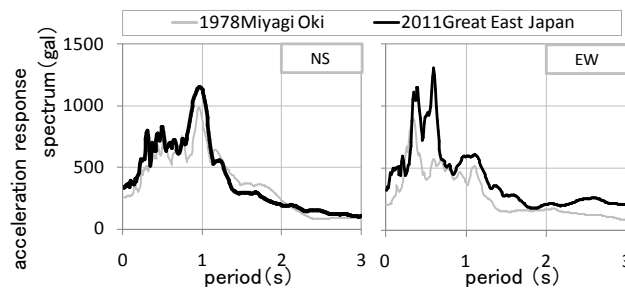
Figure 14. 5% damping acceleration response spectrum

Figure 14 shows acceleration response spectrum computed for both records (1978 and 2011) using a damping coefficient of 5%. In the NS direction, the two spectra are strikingly similar. The same is true for displacement spectra. It is reasonable to conclude that these two earthquakes produced comparable demands on the building in the NS direction.

However, even though the demands appear to have been similar (according to two separate pieces of evidence), the observed damage was completely different in 1978 and 2011, especially in NS direction.

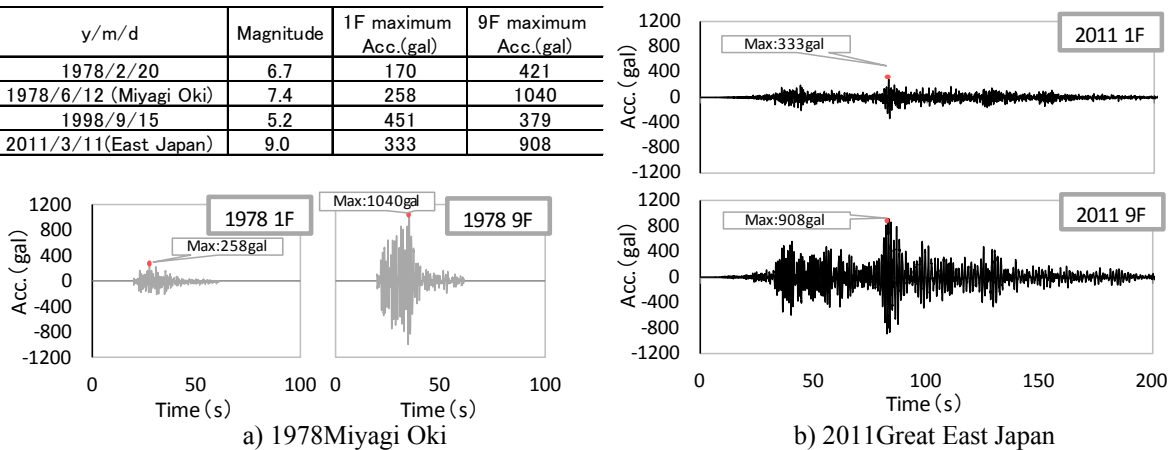
Figure15. Observed acceleration time history at NS direction

The maximum observed accelerations on the 1st floor in 1978 Miyagi Oki earthquake and 2011 Great East Japan earthquake were 258gal and 333gal, respectively. The maximum observed acceleration on the 9th floor were 1040gal and 908gal, respectively.

Comparing the two seismic records, one of the main characteristics of 2011 Great East Japan earthquake is long duration of about 180 seconds. Comparison of acceleration time history on 1st and 9th floor of the 1978 and 2011 earthquakes is shown in Figure 15.

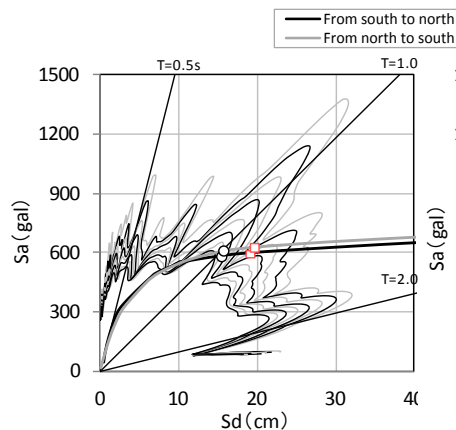
Figure 20. Result of estimated building response (1978 Miyagi Oki)

The capacity spectra (Sa-Sd) of building are plotted with response spectra of the 1978 earthquake and 2011 earthquake with 3% to 10% damping. (see Figure 20 and 21). The damping to estimate the response is calculated by Eq.(7).

The estimation results of response displacement and equivalent period agrees well with observed value on the case of 1978 Miyagi Oki earthquake(see Figure 20). However, there is big difference on the case of 2011 Great East Japan earthquake. As described at the Chapter 3, failure pattern of the building in 2011 was completely different from those in 1978, namely post installed anchors in wall panels pulled out and boundary columns were crushed.

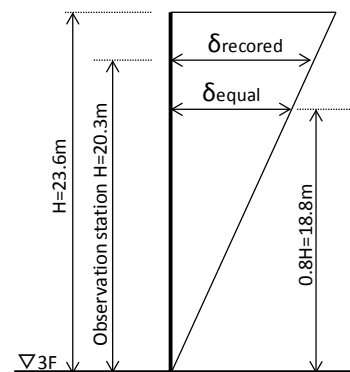
Figure 22. Displacement at equivalent height

The maximum horizontal displacement was evaluated by double integration of acceleration records observed on the 9th floor. The maximum recorded displacements at the 9th floor for the two earthquake cases (1978 EQ and 2011 EQ) are converted to the spectral displacement S_d and plotted in Figure 20 and 21 employing the assumed equivalent height of the SDOF. Specifically, the 9th floor recorded displacement is converted to the equivalent height displacement by assuming the distribution of displacement as inverted triangle from 3rd to 9th(see Figure 22) and the equivalent height is assumed at $0.8H$ ($=18.8m$).
